The Role of the Structural Model in Monument Value Preservation

Failure Mechanisms and Restoration Options from a Heritage Conservation Perspective

Kitti Fényes^{1*}, Ákos Zsembery¹

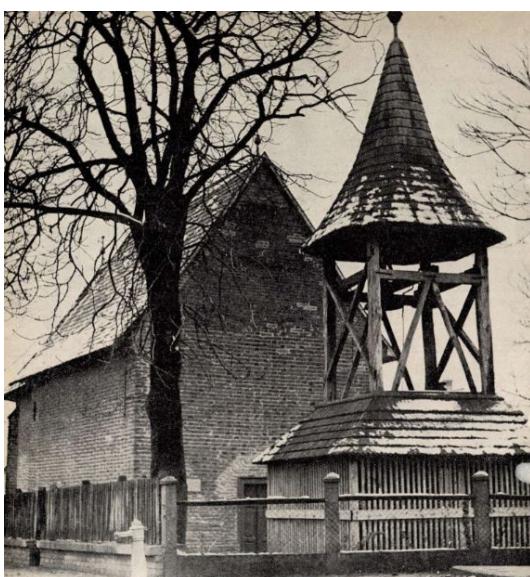
Fig. 2 Reformed church and wooden bell-tower in Szamostatárfalva
(Source: Czeglédy and Mendele, 1972)

An example of this occurred in the case of the Reformed Church in Szamostatárfalva (Czeglédy and Mendele, 1972) (Fig. 2). During renovations in 1935, a ceramic tile roof replaced the original wooden shingle covering. The addi-

tional load, combined with prior water damage to the old roof structure, led to severe deterioration.

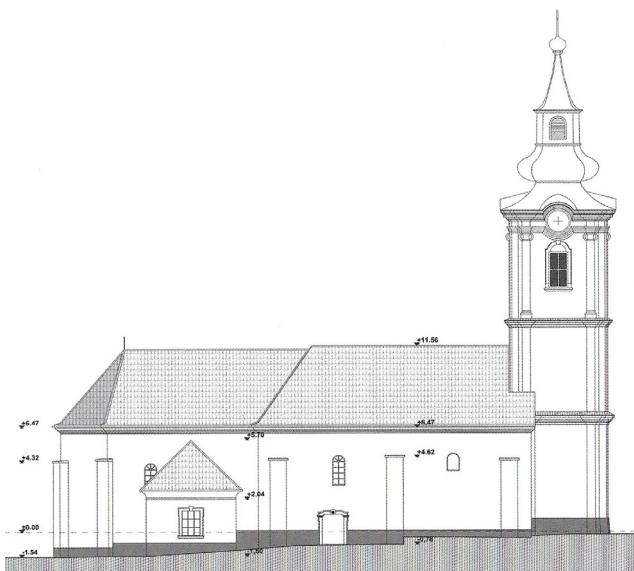
Fig. 3 Southern façade of Saint Michael Church in Érd
(Source: Krähling, 2016)

For example, it was common in church architecture to build new churches on the ruins of earlier ones. This often resulted in uneven foundations, as parts of the new structure rested on remains of the old building or on different subsoils. One such example is the Saint Michael Church in Érd (Fig. 3), which was built on the ruins of an earlier church (Gyetvainé Balogh et al., 2016). Due to the uneven subsoil and inadequate drainage, which led to the saturation of the subsoil near the foundations, the building began to settle. Over time, this caused cracking in the walls (Fig. 4) and additional damage to the vaults and roof structure (Krähling, 2016).

In this case, the primary goal was to stabilize the supporting structures before restoring the roof, as further movement of the supporting elements would have caused new damage to the superstructure (Armuth et al., 2016).

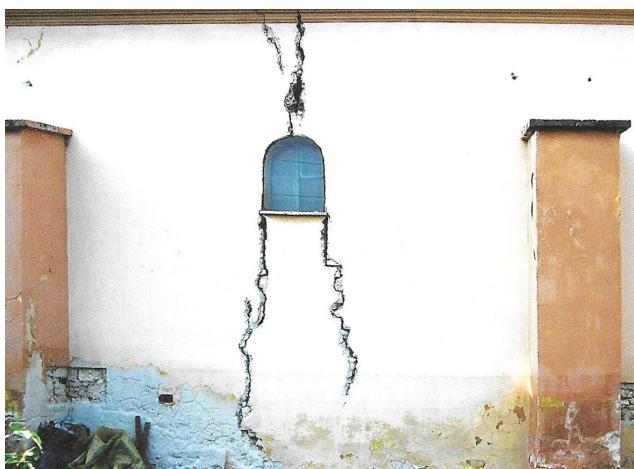
Fig. 4 The cracks on the southern facade of the Saint Michael Church before the restoration (Source: Armuth et al., 2016)

In many cases, the primary damage is not in the structure itself (e.g., a roof structure) but in its supporting elements, such as foundations, walls, vaults, or buttresses. For instance, the previously discussed restoration of the St. Michael Church in Érd (Section 5.1.4) prioritized repairing the supporting structures, enabling subsequent roof structure rehabilitation.

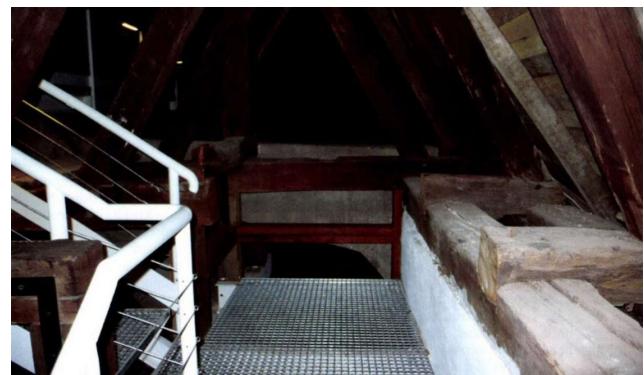
Fig. 8 The cut rafter ties of the Reformed Church in Nyírbátor (Source: Sarkadi, 2011)
