# Soluble Salt Migration in the Composite Masonry of the Ming Dynasty Kangling Tomb, the Ming Tombs, Beijing

The Ming Dynasty Kangling Tomb, one of the Ming Tombs in Beijing, exhibits notable salt weathering phenomena on the stone–brick composite structures of its Ming Tower (Minglou). Field observations reveal visible efflorescence, granular disintegration, and color changes along the lower stone courses and arch bases. This study investigates the migration and accumulation of soluble salts within different masonry materials and interfaces.

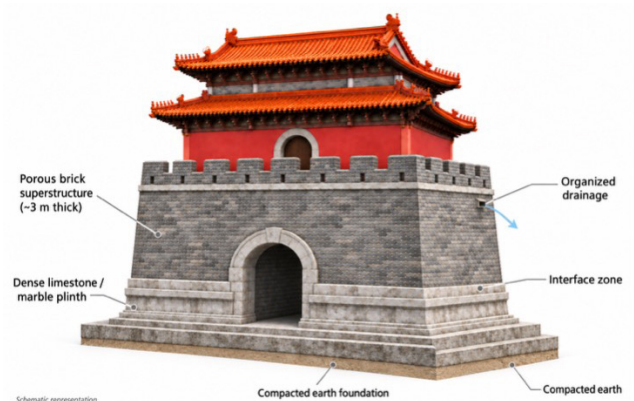
Fig. 4 Schematic diagram of the overall structure of Square City & Ming Tower and Xumizuo (Source: drawn by the author)

The overall structure of Square City & Ming Tower is composed of Ming Tower (Minglou) and Square City (Square City) from top to bottom and falls on the lower Xumizuo (Fig. 4).

The Square City & Ming Tower is composed of the lower square platform and the upper Ming Tower. In the 50<sup>th</sup> year of Qianlong, after a major overhaul by the Qing court, the structure of the Ming Dynasty Kangling Tomb's Ming Tower was changed to walls and ceiling are integrated., and the under Square City was also blocked [12]. After the founding of New China, Ming Dynasty Kangling Tomb and others were protected and repaired, and at the beginning of this century, in line with the principle of "repairing the old as the old", it was basically completed, and the Square

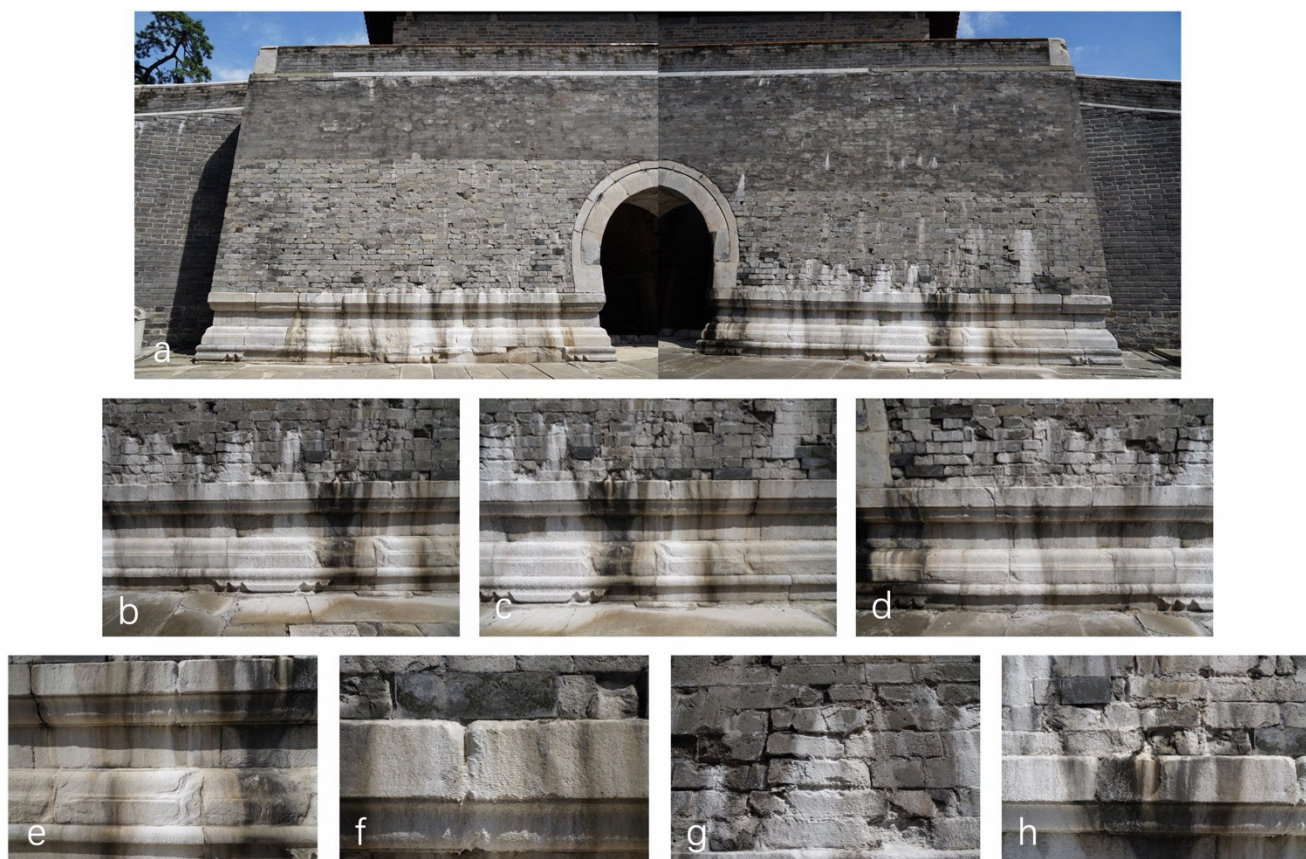
Obvious weathering and pollution can be observed on the surface of the Ming Tower in Square City, Ming Dynasty Kangling Tomb (Fig. 9), and the diseases are mainly concentrated in the middle and lower part of the wall and the Xumizuo area.

As shown in the figure, the surface of the brick wall forms an obvious brick wall color difference line from the position of the vaulted. The lower brick shows light gray to grayish-white as a whole, forming a clear boundary with the darker brick wall in the upper part. In some areas, continuous white deposits can be seen adhering to the brick surface and the plaster joints used for repair, and some brick surfaces appear whitening.

There are obvious vertical flow marks on the surface of the wall, extending from the upper part of the brick wall down to the Xumizuo area, forming white strip-like traces. Some of the flow traces run through the brick wall and the stone Xumizuo, and the color deepens and sedimentary aggregation occurs at the turning point of the components.

**Fig. 9** Visible salt deposits and their spatial distribution on the Square City at the Ming Dynasty Kangling Tomb: (a) Overall view of the façade showing the affected areas; (b) Salt deposits and dark staining on the left-hand section of the Xumizuo and adjacent brickwork; (c) Salt deposits along the brick–stone interface and joints of the Xumizuo; (d) Distribution of salt deposits across the right-hand section of the Xumizuo and adjacent brickwork; (e) Close-up of dark staining and white deposits on the Xumizuo; (f) Close-up of white deposits along a vertical joint between stone blocks; (g) Close-up of white deposits on the brickwork and mortar joints; (h) Close-up of white deposits and dark streaks at the brick–stone interface. (Source: Photographs by the author.)

There are different degrees of material deterioration in brick masonry, including loose brick surface, edge damage, local loss and mortar degradation. The diseases in the lower brick wall area are relatively concentrated, and some brick surfaces have uneven weathering and hole-like defects.

Obvious pollution and deposition phenomena can be seen on the surface of the Xumizuo stone components, especially in the Waist section, Upper cyma molding and recessed band, there are continuous black flow marks and white attachments. The surface color of some areas is uneven, accompanied by local weathering and abrasion.

The overall disease has a strong regularity in spatial distribution, mainly developing along the vertical direction of the wall, and is more obvious in the masonry junction and the turning point of the components.

At Ming Dynasty Kangling Tomb, the observed distribution is characterized by three related features: a visible colour boundary near the level of the arched entrance, vertical streaks crossing the brick–stone junction, and

localized deposits on the waist, upper cyma molding, and recessed bands of the Xumizuo (Fig. 9). Together, these observations identify specific areas in which moisture movement and deposition may be linked. They provide a spatial basis for the subsequent interpretation, although the photographs alone do not establish the direction of internal moisture transport or the chemical composition of the deposits.

For Kangling, the immediate conservation priority is therefore targeted investigation of the lower brickwork, the brick-stone junction, and the deposit-bearing moldings of the xumizuo. Paired sampling of affected and less affected areas, examination of original and repair mortars, and monitoring of wetting and drying at these locations would provide a basis for selecting compatible interventions. The observations offer a basis for comparison with other imperial mausoleums, but their applicability elsewhere requires verification against local construction and exposure conditions.
