Evaluation of the Two Faces Water Level Dynamics and its Impact on the Stability of Railway Embankment Infrastructures

The Nanhu railway embankment, located between two lakes, experiences seasonal water level fluctuations. This study aims to assess the impacts of these fluctuations on embankment seepage, stability, and deformation conditions. Firstly, field observations and laboratory experiments were conducted to determine the hydro-mechanical properties of the embankment material and the drawdown scenarios. Subsequently, GeoStudio 2D and PLAXIS 2D software were used for numerical analysis. The analysis demonstrates that the combined impact of a train static load (130–150 kPa) with lowering drawdown and increasing water level scenarios affects the stability of the embankment, resulting in more deformation than the falling scenario. The model result showed a maximum displacement of 238.43 mm, which was corroborated by the observed field data. Furthermore, the rising scenario had a minimal safety factor of 0.9128, and the falling scenario yielded a minimum safety factor of 0.9312, indicating severe instability. Furthermore, the findings indicate that understanding the relationship

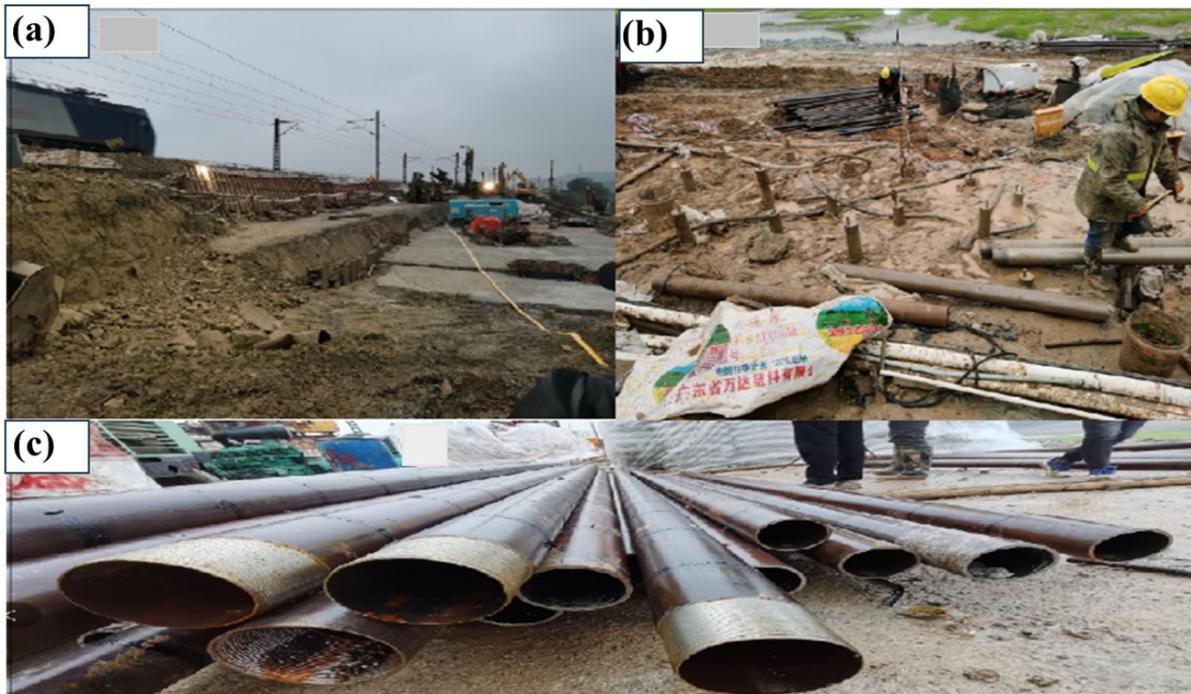
Fig. 5 (a) Failure surface (b) Grouting process (c) Steel pipe (SP) materials

Generally, two kinds of connections are common for the Concrete filled steel-tube pipes grouting. These are reinforcement threaded and welding casing connections. In this study, Concrete filled steel-tubes (CSTs) were selected for their enhanced stiffness, compressive capacity, and ductility compared to concrete columns reinforcement. Stringent measures were taken to ensure that the connecting joints were free from all kinds of impurities. However, the usual CSTs are susceptible to corrosion of the outer surface. To mitigate corrosion, the CSTs were coated with anti-corrosive Epoxy Resin, providing protection against harsh environmental conditions. The CSTs used had two different sizes: $\varnothing 108 \text{ mm} \times 6 \text{ mm}$ at 90° and $\varnothing 60 \text{ mm} \times 4 \text{ mm}$ at $60^\circ/30^\circ$. The CSTs connected with threaded ends were precisely placed at 1 m and 2 m equidistant row-wise into drilled holes, corresponding to their respective sizes and depths. The $\varnothing 108 \text{ mm} \times 6 \text{ mm}$ CSTs were placed at a depth of 28 m, while the $\varnothing 60 \text{ mm} \times 4 \text{ mm}$ CSTs were positioned at 15 m depth. The numerical analysis was conducted using the same CST specifications and arrangement as in the fieldwork, ensuring consistency between the two sets of data. Detailed information on the CST arrangement and specifications used in the study can be found in Fig. 1 (a), Fig. 5 and Table 3, providing an overview of the CST implementation for grouting reinforcement. In the numerical study, a sensitivity analysis of the angle of placement was conducted. Firstly, all CSTs grouting were placed vertically at 90° , and the safety factor was determined. In the second case, the tube with the smaller diameter was placed at $30^\circ/60^\circ$, while the others remained at 90° . This analysis is presented to optimize the reinforcement strategy required to enhance slope stability, minimize risks of failure, and improve overall embankment performance. The placement of the steel pipe grouting, as illustrated in Fig. 1 (a), was determined based on the observed geotechnical behavior of the embankment and prior failure occurrences in the study area. Specifically, the grouting was introduced within the identified failure-prone zone, as shown in Fig. 1 (b), where differential hydraulic loading between the left and right lakes resulted in significant seepage forces and potential instability. It is important to note that the steel pipes themselves were not

The November 5, 2020 failure (Fig. 5 (a)) necessitated testing how a railway embankment reacts to increasing water levels on both sides, focusing on seepage, displacement, and stability. The study indicated that the Nanhu railway embankment's stability is affected by fluctuating lake water levels on both sides and track static load. These loads generate swift differential settlement, pore-water pressure changes, and factor of safety changes, with the maximum displacement recorded during increasing scenarios. The embankment is least safe with rising water levels, usually between April and October. The study also shows that a sudden decline rate, exceptionally high-water level, and track static loads negatively impact railway embankment stability. Thus, an early warning system for lake water levels is needed to direct railway operations during lake water level variations, which can damage the embankment. Also, the following are the key findings of this study: The stability factor of the Nanhu railway embankment drops from 2.116 to 0.9128 when the lake water level rises 0.1 m/day from 53.5 m to 71.2 m and 53.5 m to 58 m. In the second scenario, the water level drops at 0.2 m/day and the embankment stability factor drops from 2.1256 to 0.9312. The stress state to be considered when designing this type of railway embankment is the scenario of rapid lowering of water levels because the stability is weakest at this stage. The numerical analysis shows that fast water level changes and prolonged immersion influence the railway embankment's stability. This caused significant deformations of 232.69 mm, 238.43 mm (SIGMAW), and 240 mm (PLAXIS 2D [16]), notably at high water levels and vehicle loads. Observations from monitoring points across the failed surface revealed inconsistent displacement curves, indicating partial deformation. Notably, the K1430 + 110 failed surface displayed a step-like displacement pattern, attributed to repeated fluctuations in lakes levels. Analysis of displacement time curves suggested a seasonal cycle closely linked to hydrological factors like lake levels and rainfall. The slope movements exhibited rapid displacement over short periods, succeeded by prolonged low strain rates. As shown
